**MicroVision Labs Coal Ash Report, Job Number: 13409**

**CDW Consultants, Inc. Project Number: 1830**

**CDW Consultants, Inc. Project Name: Beaver St**

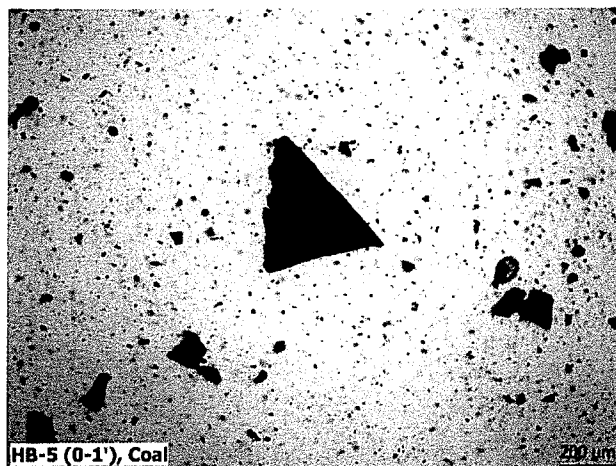
**Coal:** This particle type consisted of eleven (11) shiny, black grains approximately 1-3mm in diameter. The PLM examination indicated this particle type to be consistent with coal. The PLM and SEM images of this particle type show the angular edges and typical conchoidal fractures found in coal.

**PLM Image**

**SEM Image**

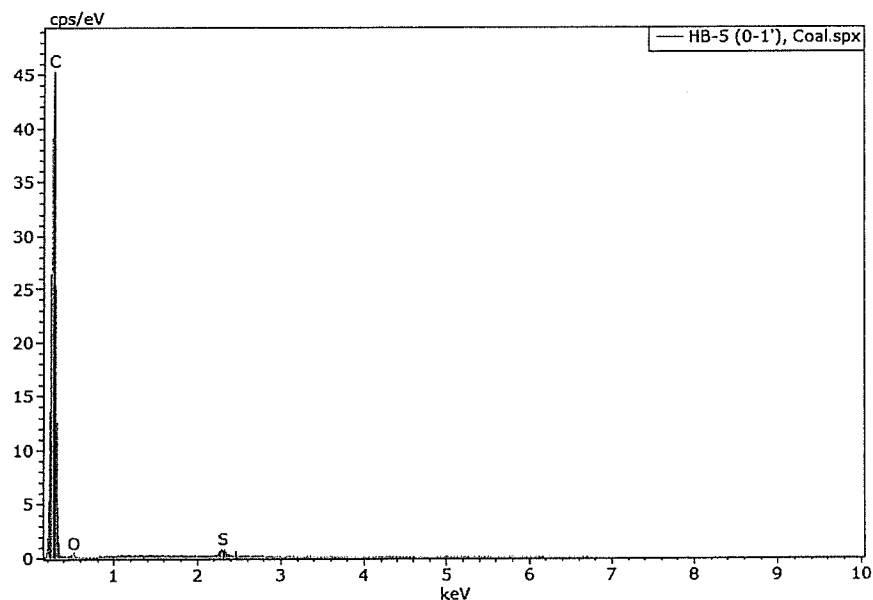
The EDS spectrum, shown below, confirms that this particle type is coal. The analysis for this particle shows concentrations of carbon, oxygen and sulfur.

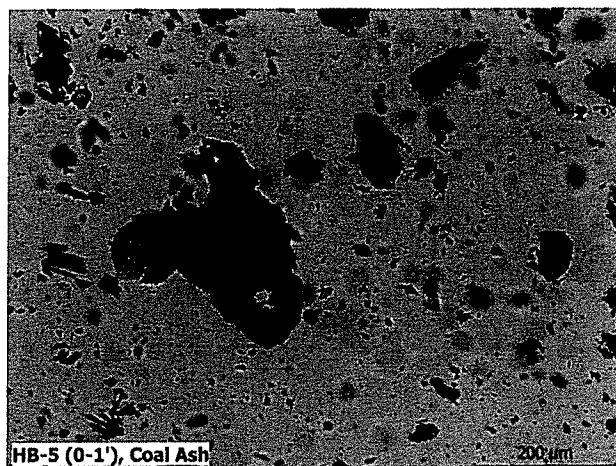
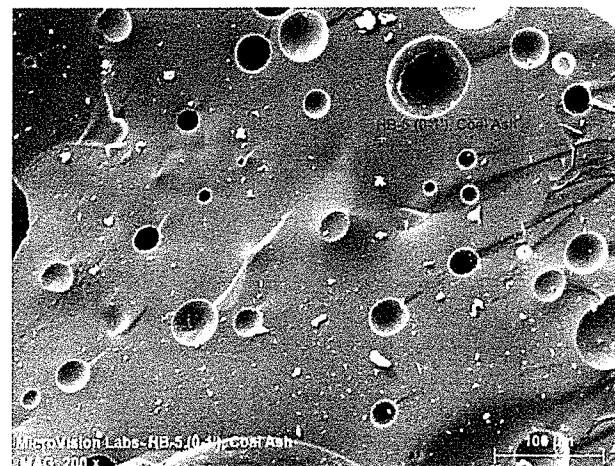
**Coal Ash:** This particle type consisted of four (4) dark, porous grains approximately 1-3mm in diameter. The PLM examination indicated this particle type to be consistent with coal ash. The PLM and SEM images show the spherical gas voids that formed during combustion.

PLM Image

SEM Image

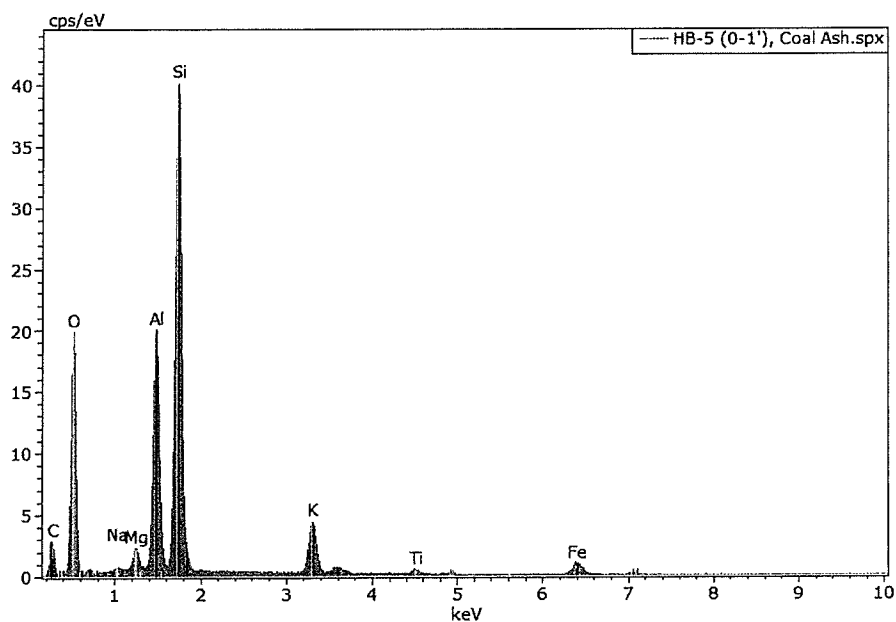
The EDS spectrum, shown below, indicates this particle type is coal ash. The analysis for this particle shows concentrations of carbon, oxygen, sodium, magnesium, aluminum, silicon, potassium, titanium and iron.

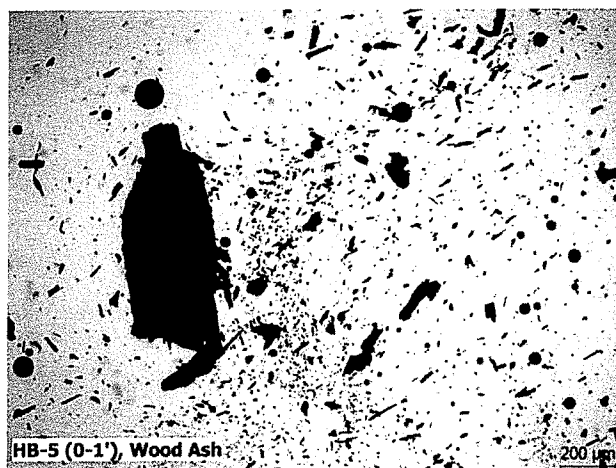
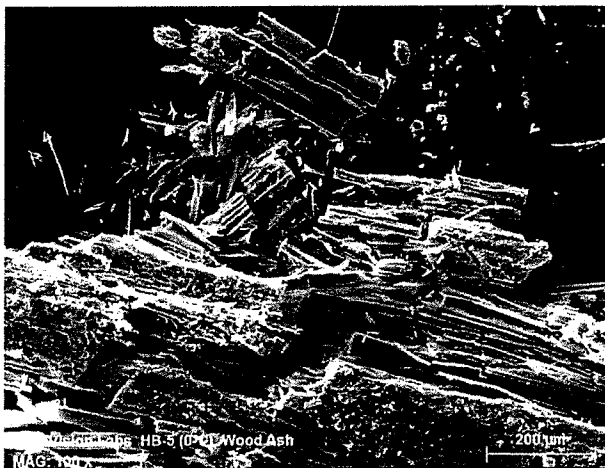
**Wood Ash:** This particle type consisted of two (2) friable, black grains approximately 2mm in length. The PLM examination indicated this particle type to be consistent with wood ash. The PLM and SEM photos show the cellular structure typical of wood still present in these grains.

PLM Image

SEM Image

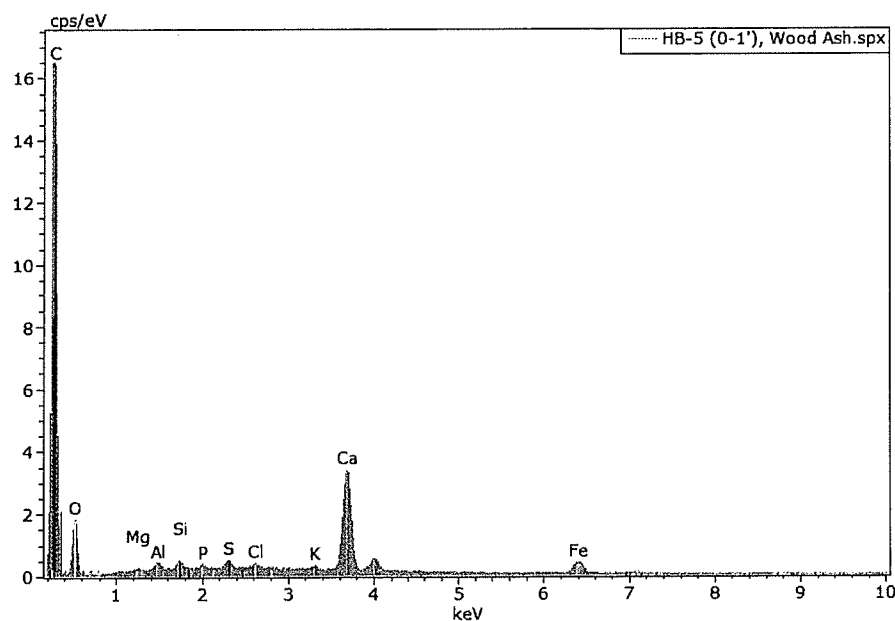
The EDS spectrum, shown below, indicates this particle type is wood ash. The analysis for this particle shows concentrations of carbon, oxygen, magnesium, aluminum, silicon, phosphorus, sulfur, chlorine, potassium, calcium and iron.

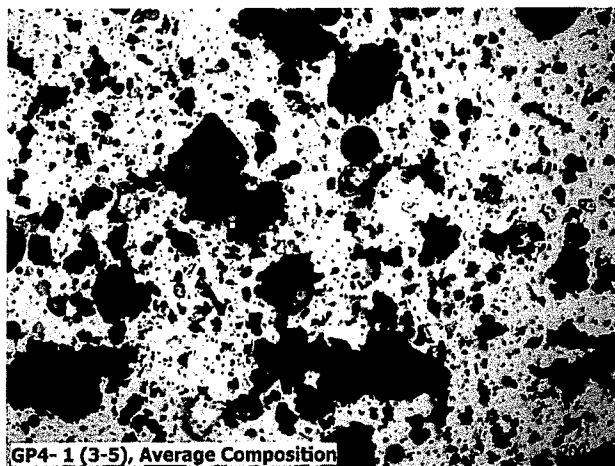
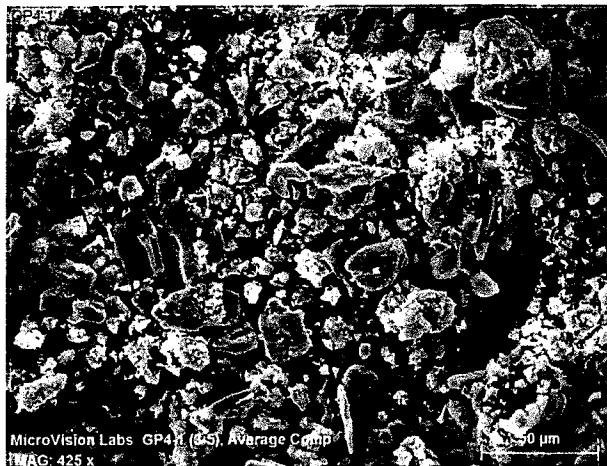
**Minerals:** This particle type consisted of over one hundred (100+) shiny, dark grains 1-10mm in diameter. The PLM examination indicated this particle type to be consistent with mineral matter. The PLM and SEM images of this particle type are shown below.

PLM Image

SEM Image

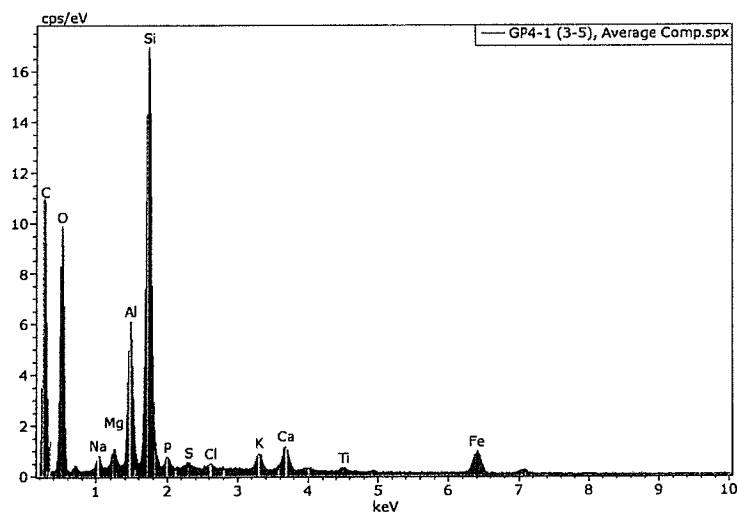
The EDS spectrum results, shown below, indicate this particle type is minerals. The analysis for this particle shows concentrations of carbon, oxygen, sodium, magnesium, aluminum, silicon, phosphorus, sulfur, chlorine, potassium, calcium, titanium and iron.

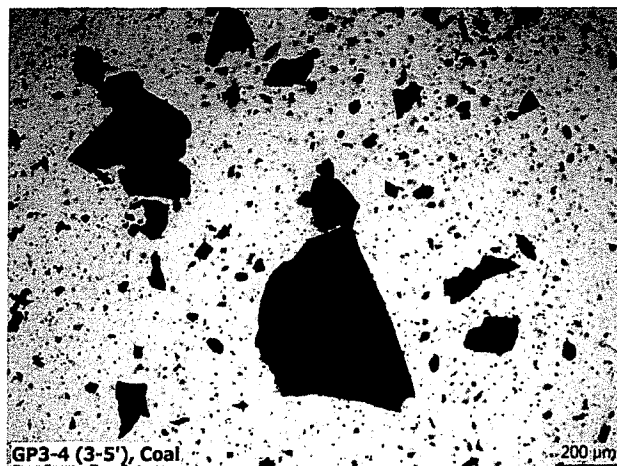
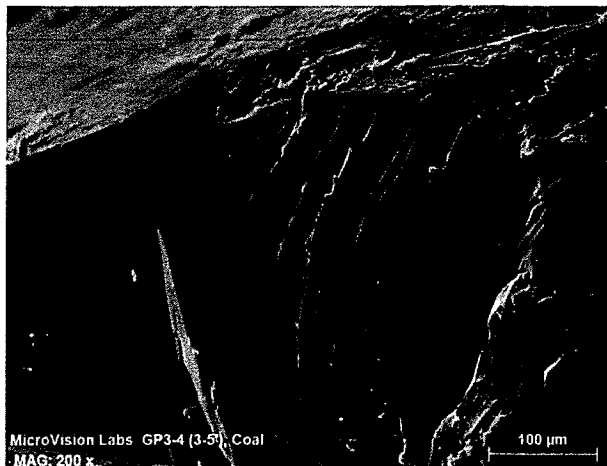
**Coal:** This particle type consisted of six (6) shiny, black grains approximately 1-3mm in diameter. The PLM examination indicated this particle type to be consistent with coal. The PLM and SEM images of this particle type show the angular edges and typical conchoidal fractures found in coal.

PLM Image

SEM Image

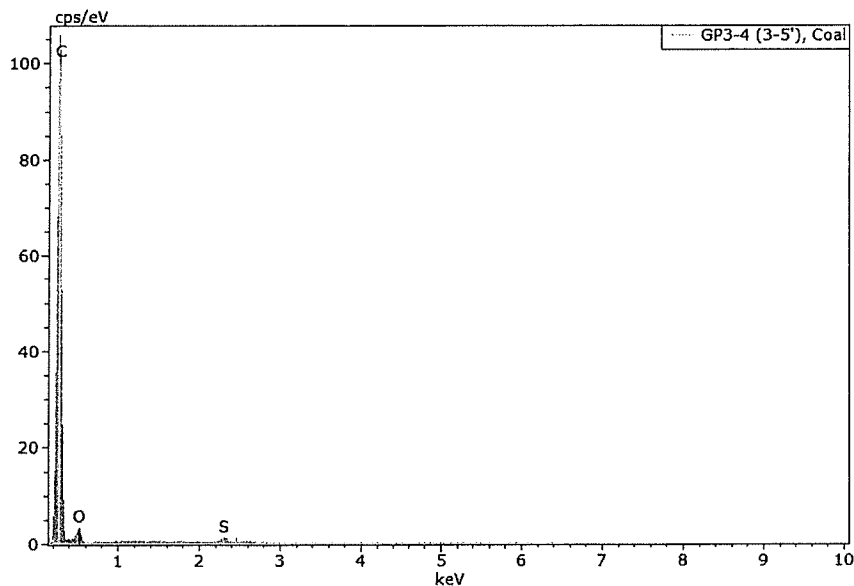
The EDS spectrum, shown below, confirms that this particle type is coal. The analysis for this particle shows concentrations of carbon, oxygen and sulfur.

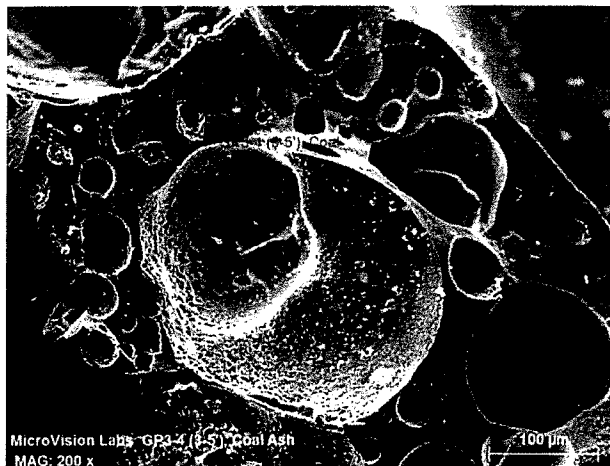
**Coal Ash:** This particle type consisted of two (2) dark, porous grains approximately 2-4mm in diameter. The PLM examination indicated this particle type to be consistent with coal ash. The PLM and SEM images show the spherical gas voids that formed during combustion.

PLM Image

SEM Image

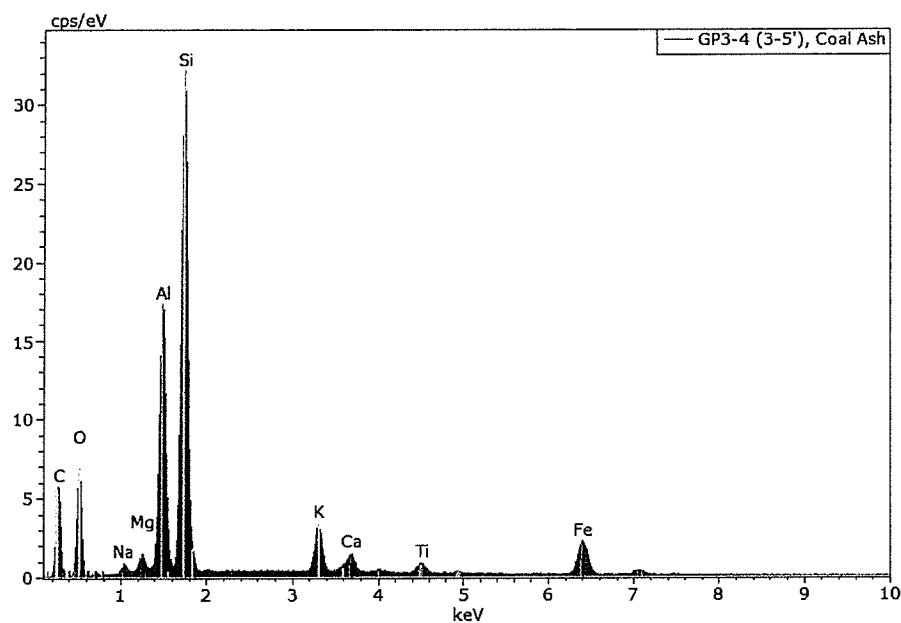
The EDS spectrum, shown below, indicates this particle type is coal ash. The analysis for this particle shows concentrations of carbon, oxygen, sodium, magnesium, aluminum, silicon, potassium, calcium, titanium and iron.
